# EMERGENCY AIRWORTHINESS DIRECTIVE

**DATE: April 10, 2001**  
**2001-08-51**

## **2001-08-51 CFM International (CFMI): Docket No. 2001-NE-08-AD**

This emergency AD is applicable to CFM56-5C turbofan engines. These engines are installed on, but not limited to Airbus Industrie A340 airplanes.

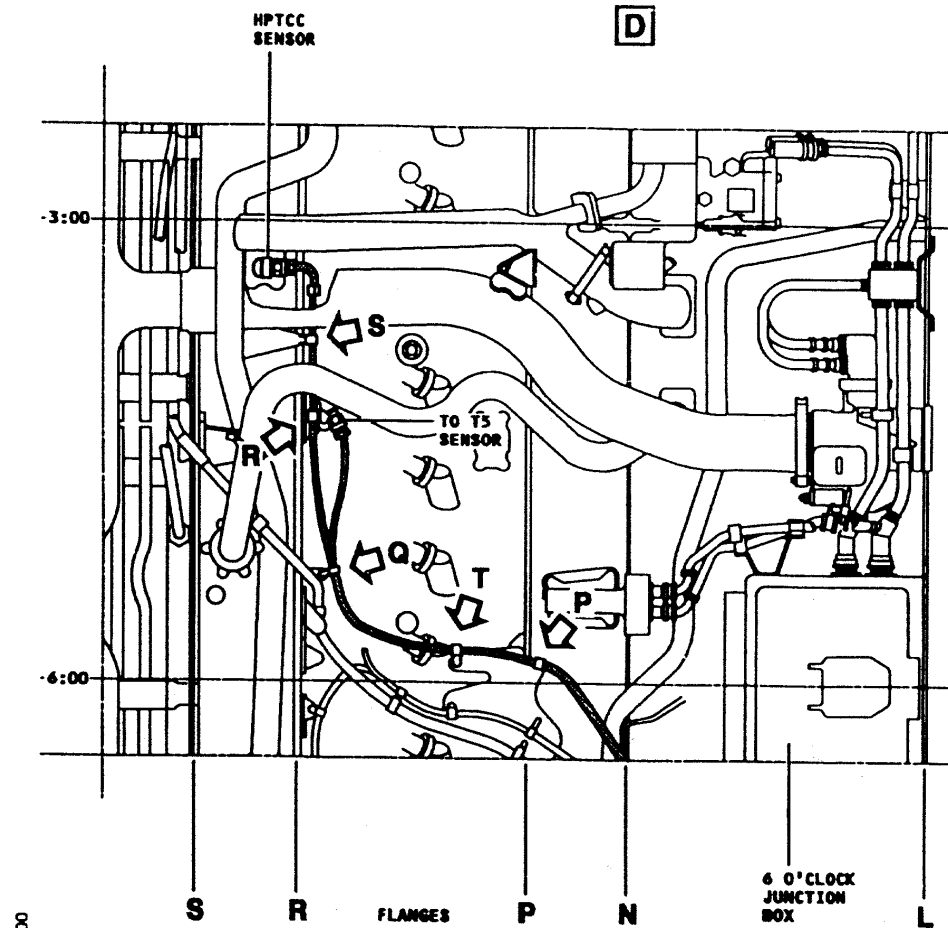
Removal/Installation of the CJ9L Wiring Harness  
Figure 401/TASK 73-21-50-991-022- 69 (SHEET 6)

This emergency Airworthiness Directive (AD) is prompted by a recent report of a significant engine fuel leak under the thrust reverser cowls at the fuel manifold level. The leak was confirmed to be coming from a hole in the fuel manifold pigtail. The hole was a result of interference and chafing between the CJ9L harness high pressure turbine clearance control (HPTCC) sensor lead and fuel manifold. This is the second fuel leak event at this location. Additional engine inspections by the operator who experienced the engine fuel leak discovered two other engines exhibiting interference of the CJ9L harness with fuel manifold and chafing of the fuel manifold. The investigation has identified three causes for lack of clearance between the HPTCC harness and the fuel manifold:

- (1) Incorrect routing the CJ9L harness
- (2) Incorrect orientation of the CJ9L harness cushion clamps, and
- (3) Wear of the silicone material in the clamp which allows the harness to move within the clamp. This clamp material is used on older configuration clamps. The later configuration uses a metallic material.

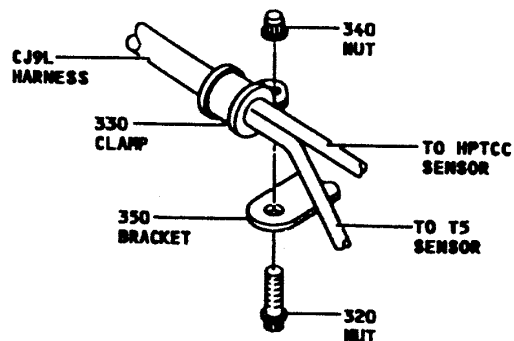
**Q** POST SB 72-069

(4) Visually inspect the silicone material clamps for wear and harness looseness at details Q, R, and S as shown in Appendix 1 of this AD, and before further flight, replace clamps if worn or if harness is loose.

(c) Replacement of existing clamps (red and brown silicon) at details Q, R, and S of CJ9L harness with new clamps part numbers 649-412-351-0 and 649-412-354-0 constitutes terminating action for the repetitive inspection requirements of paragraph (b) of this AD.

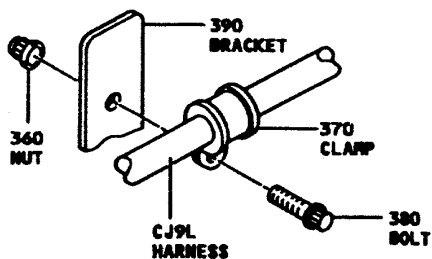
**R**

(3) Visually inspect and, if necessary, correct the bracket and clamp locations at details R and S of the CJ9L harness as shown in Appendix 1 of this AD, titled "Figure 401 of Airbus Maintenance Manual AMM ATA 73-21-50" in accordance with paragraphs 3 through 3.c. of AOW No. 01/CFM56/425, dated April 10, 2001.
